# Manhole Inspection Summary

Manhole # S21KK1009MH

Insp Date: **11/20/06 10:02 AM**

**Location** Address: **4434 CLYDESDALE AVE** Cross Street: **BUENA VISTA AVE**

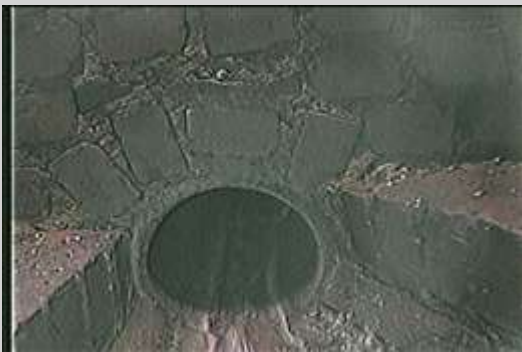
### 8 in. Circular Gravity Sewer Pipe Out @ 12 O'Clock

Infiltration: **None** Pipe Seal Cond: **Unknown**

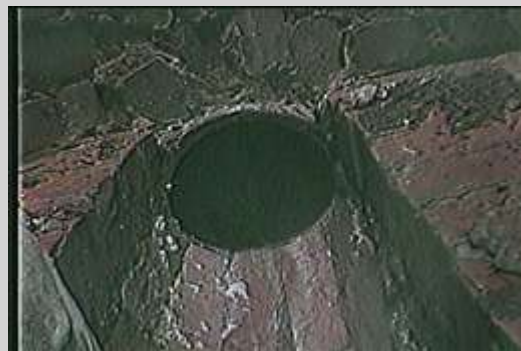
### Drop In @ 4 O'Clock

Drop: **Outside** Rod and Bar

Angled: **Yes** Reading: **9.13** (ft.)

Drop Condition: **Open**
